# TurboDraft™

FIRE E D U C T O R

## Lakefront House Fire

DISTANCE: 50'  
LIFT: 18'  
LOCATION: SOUTHERN MICHIGAN  
CHALLENGE: DISTANCE AND LIFT TOO GREAT FOR TRADITIONAL DRAFTING TECHNIQUES

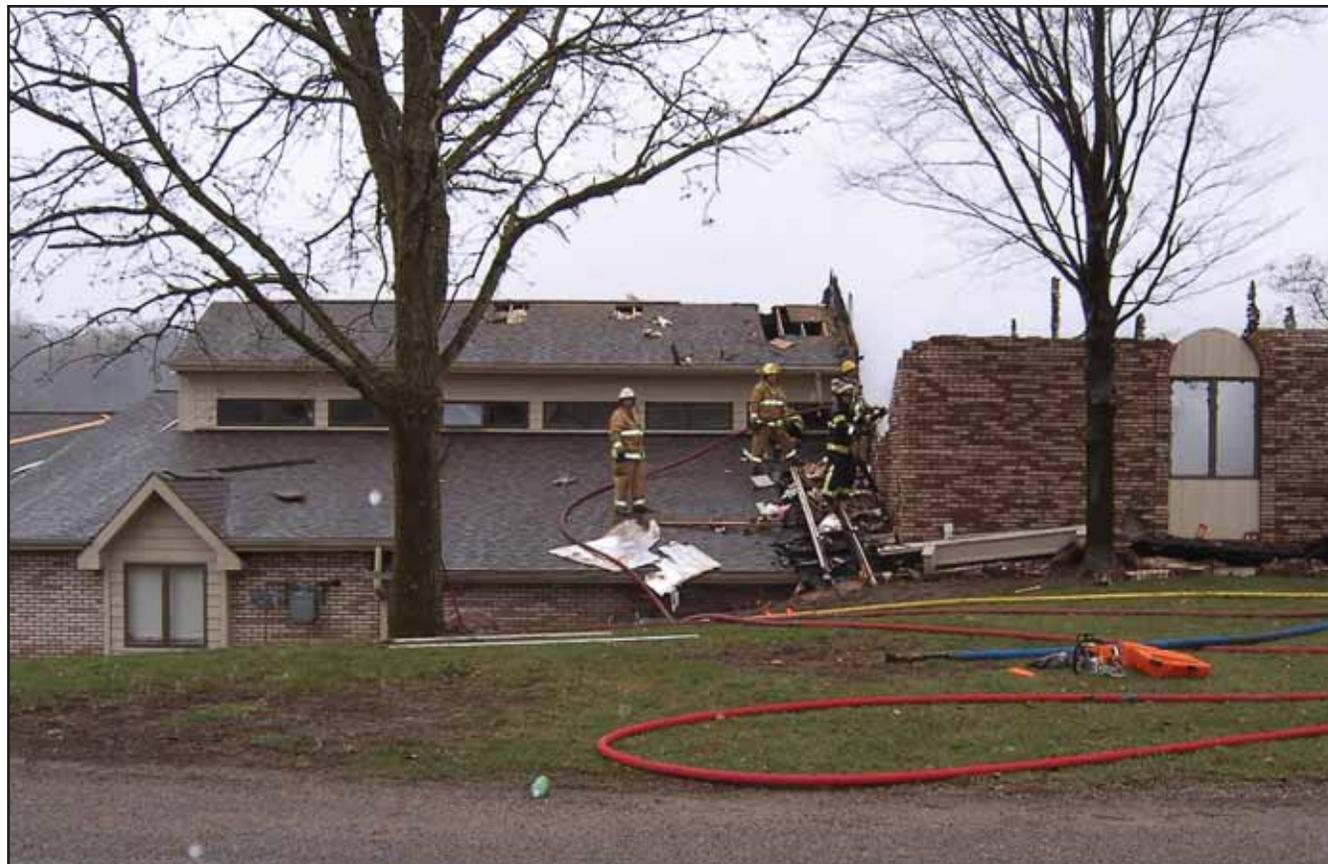
The following photos were from a working house fire on April 23, 2005. This was a million dollar house on a dead end driveway that has a lake on both sides of the house. Note that water supply engine was providing water from the lake with one TurboDraft with approx. 18 foot lift with 50 foot of 5" supply hose and then they kept the fold-a-tank full for the attack engine fighting the fire. That Fire Department is picking

up their suction hose that they could not get a draft from the lake at the same location as the TurboDraft due to the lift. The West end of the structure was fully engulfed when they arrived and there was a 25 mile per hour wind out of the North. The Fire Department ran out of water during their initial attack and was waiting for another Fire Department to arrive to supply the attack engine from the lake. Due to the tight road conditions a water shuttle was not safe. All the attack lines were supplied by one TurboDraft. The crews were able to stop the fire at the center of the structure which was an indoor pool area, 2 stories and which was connected to the East end structure which was an additional 2 story house. There were 5 fire departments on scene to put this fire under control with only one TurboDraft being used to supply all the attack engines being used.

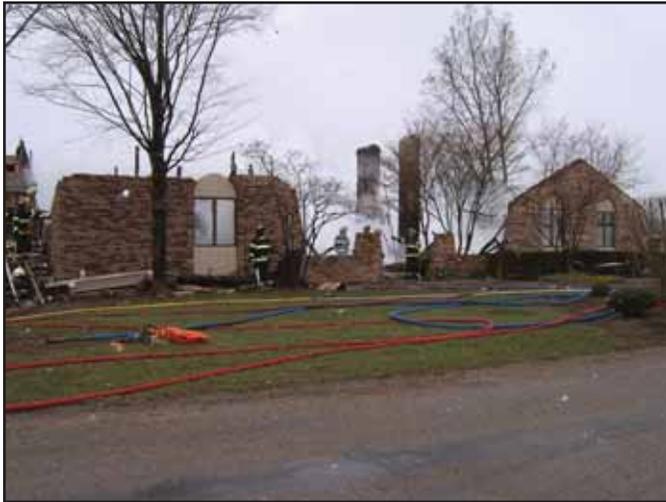
All lines being water supply from one TurboDraft supply. One-half of the million dollar home West end.

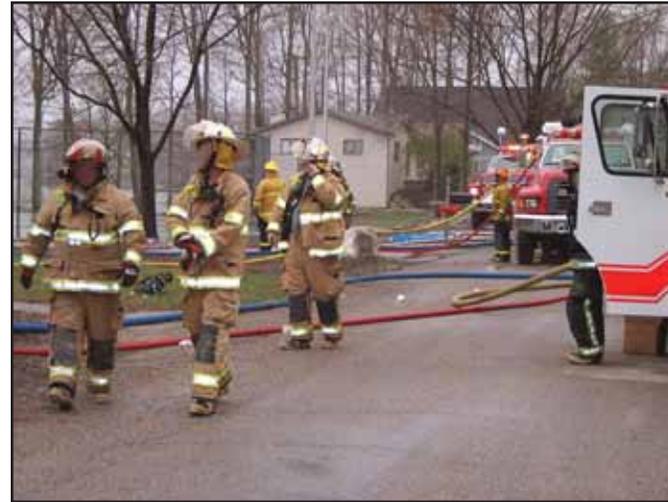
No way to do a water shuttle due to tight driveway and dead end at lake.

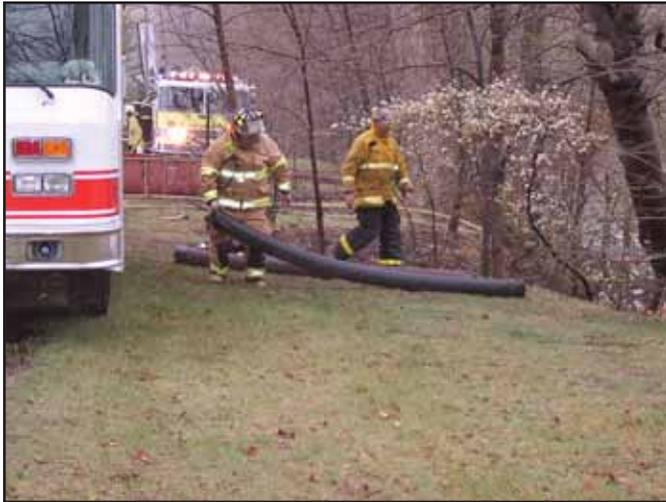
First in engine tried to pull a draft from the lake with suction hose and was unable to do so due to high lift and distance away from lake.

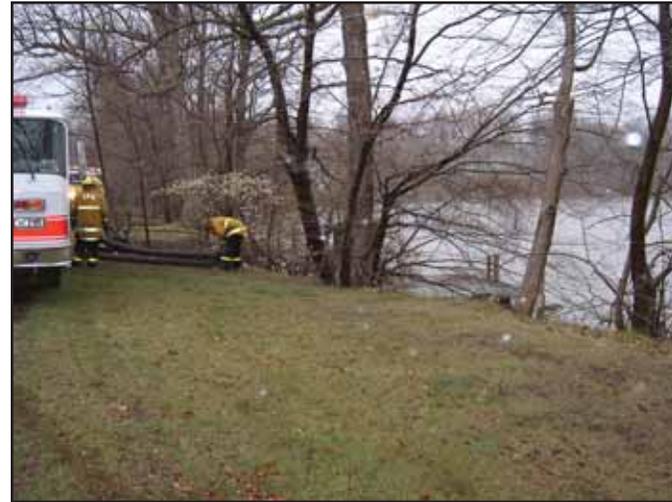
The lake and distance from water that they could not draft from but we used a TurboDraft in the same area behind this engine.

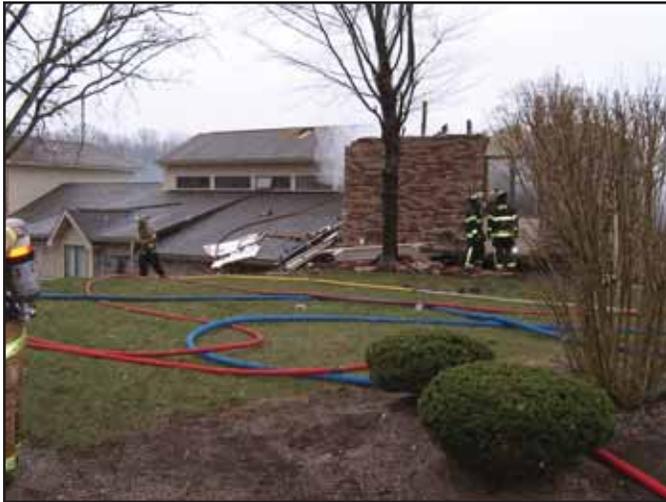
Shows where the fire was stopped after water was provided by the TurboDraft.

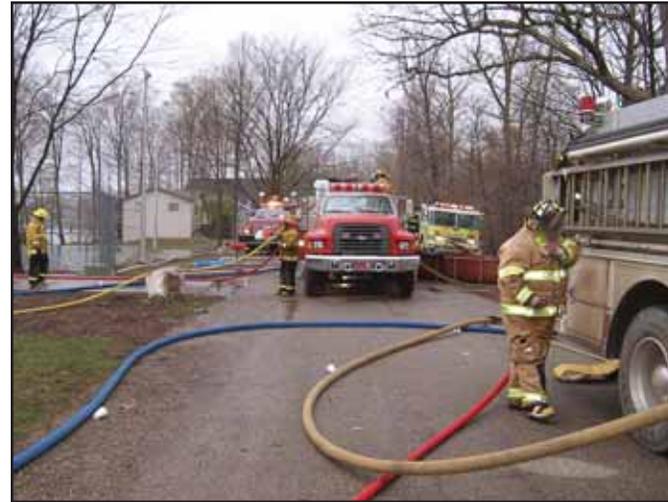
The red engine is drafting from the portable tank and then supplying the hand lines. The tank is being supplied by another engine with one TurboDraft from the lake.

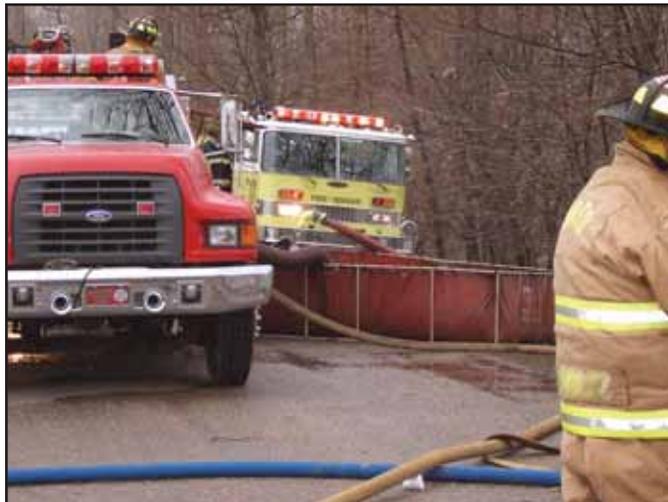
Red engine is drafting from fold-a-tank for attack lines and the yellow engine is TurboDrafting and supplying the water to the fold-a-tank.

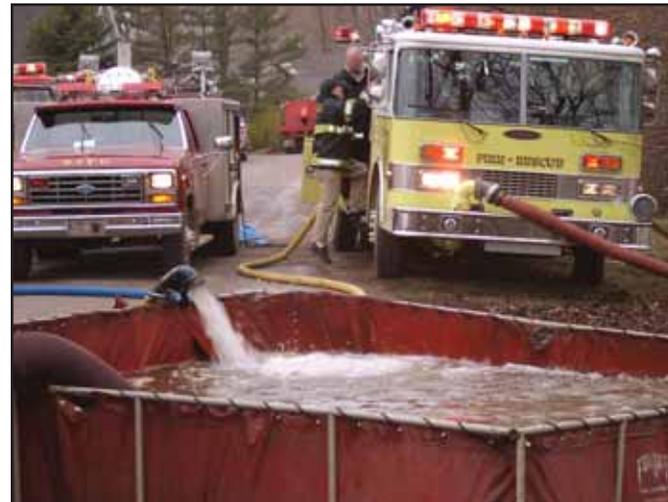
Close-up of the water supply from the yellow engine which was TurboDrafting.

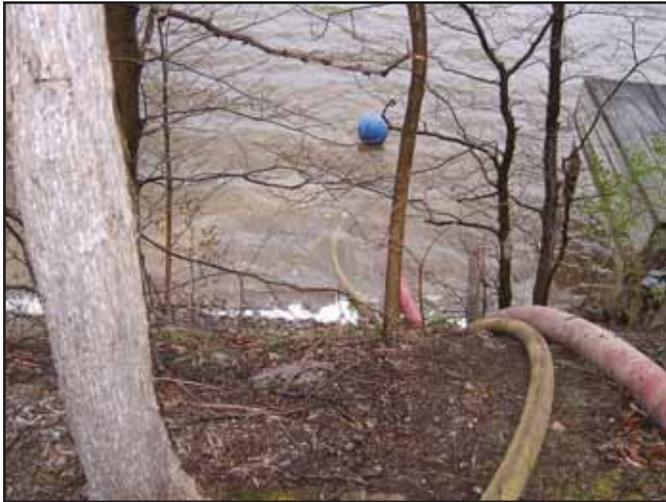
Blue ball in water shows the one TurboDraft floating in the lake down an 18 foot drop from the front suction of the yellow engine. This is one 50 foot section of 5" and one 50 foot section of 2-1/2" with 18 foot of lift.

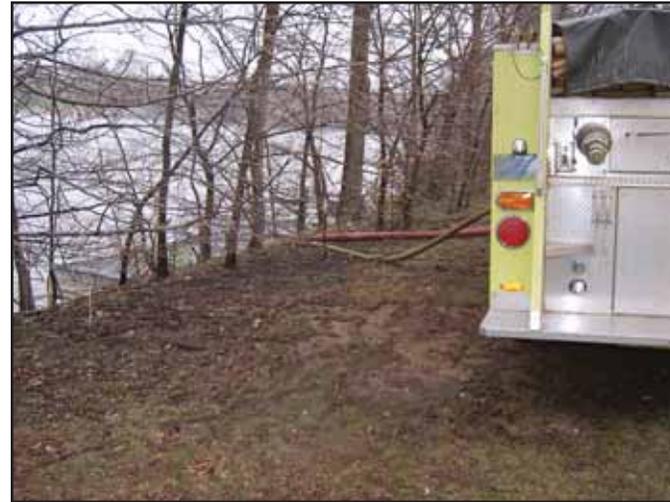
Hose from the supply engine going down to the lake.

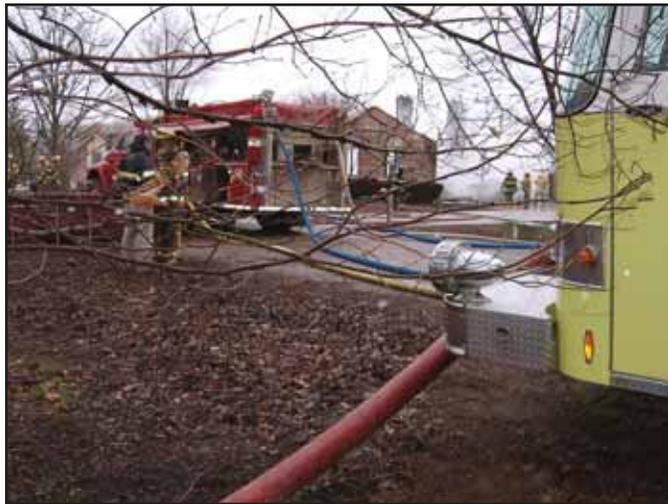
TurboDraft going to the front suction of yellow engine and the house burning in the background.

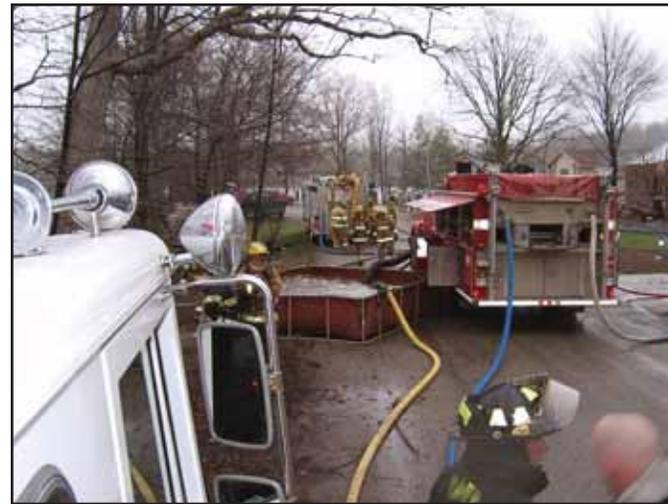
The fold-a-tank is being filled from the TurboDraft engine.

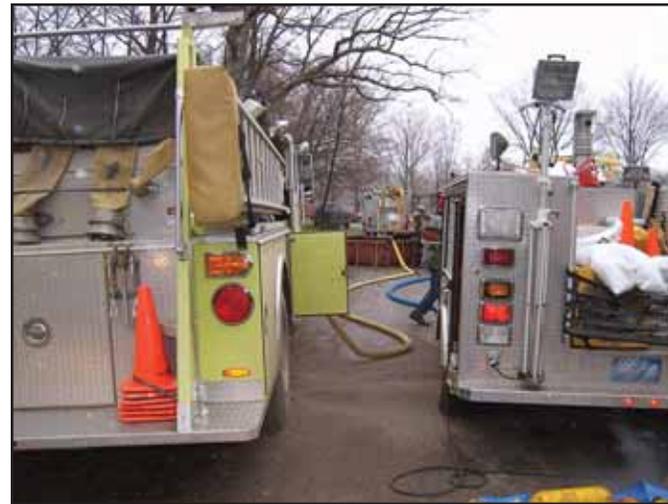
Supply lines going up the driveway to the fold-a-tank of the attack engine.

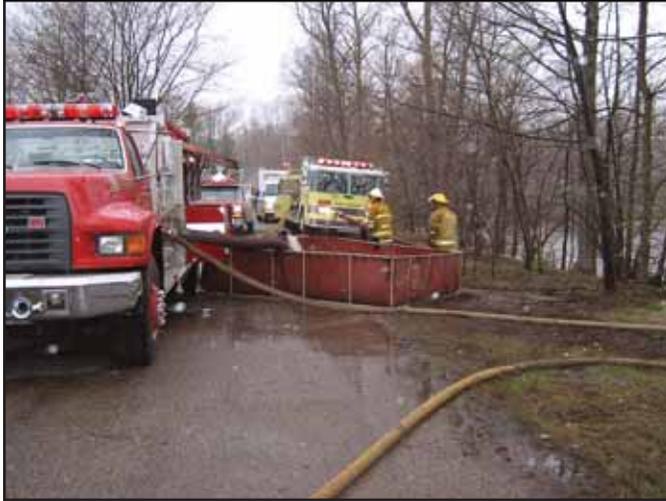
Shows the attack engine drafting from the fold-a-tank which is the only water supply unit being used without any tanker shuttle - only one TurboDraft.

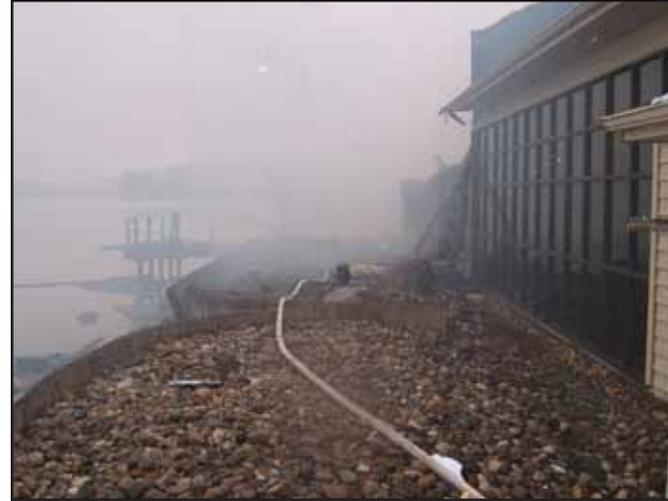
This is the South side of the house showing how close the house was to the lake but was not able to use the water on this side of the house without the TurboDraft.
