Limited Access Roadway

LOCATION: BUCKS COUNTY, PA

CHALLENGE: GUARDRAIL AND VEGETATION RESTRICTING ACCESS TO

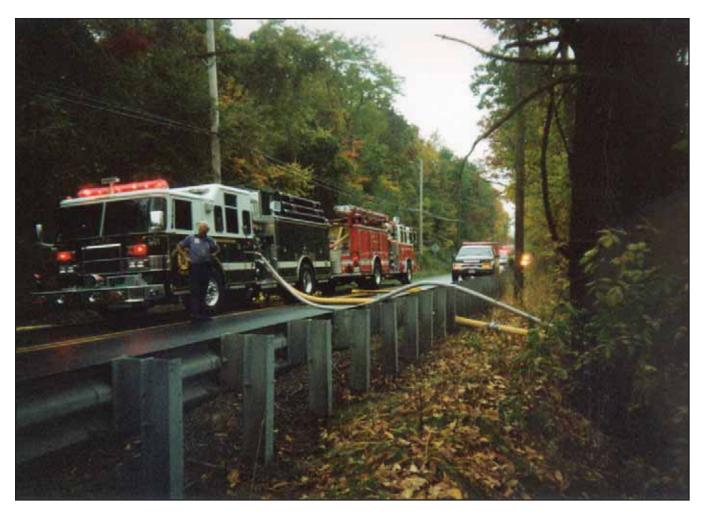
A gasoline tanker truck and a dump truck side-swiped each other and the tank was Due to the compromised. narrow road and the spill, a tanker shuttle could not easily be setup. The tankers would have had to back up a very long distance to reach the incident site. The Delaware Canal was approximately 75 ft from the road and was accessed by a Turbodraft to provide water for foam application which was required until the situation was stabilized. The green truck is using the Turbodraft to access Delaware Canal and supplying the red truck that is supporting the incident with water supply.

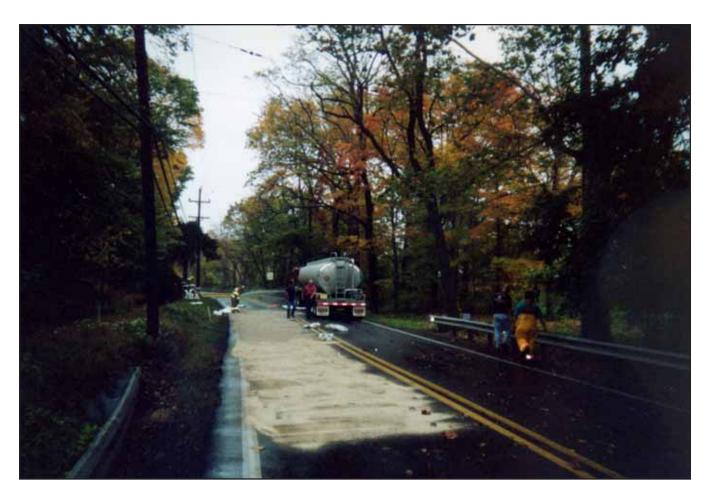
View of the scene from the other side of the incident showing the clean up after the situation was stabilized.
